## Report Number 2023-022231 - Traffic Crash - 1 Report

REPORT TAKEN LOCATION  
DEXTER AVE N & THOMAS ST, SEATTLE, WA 98109

Case Investigation Report: #2023-022231 TCIS #23-003

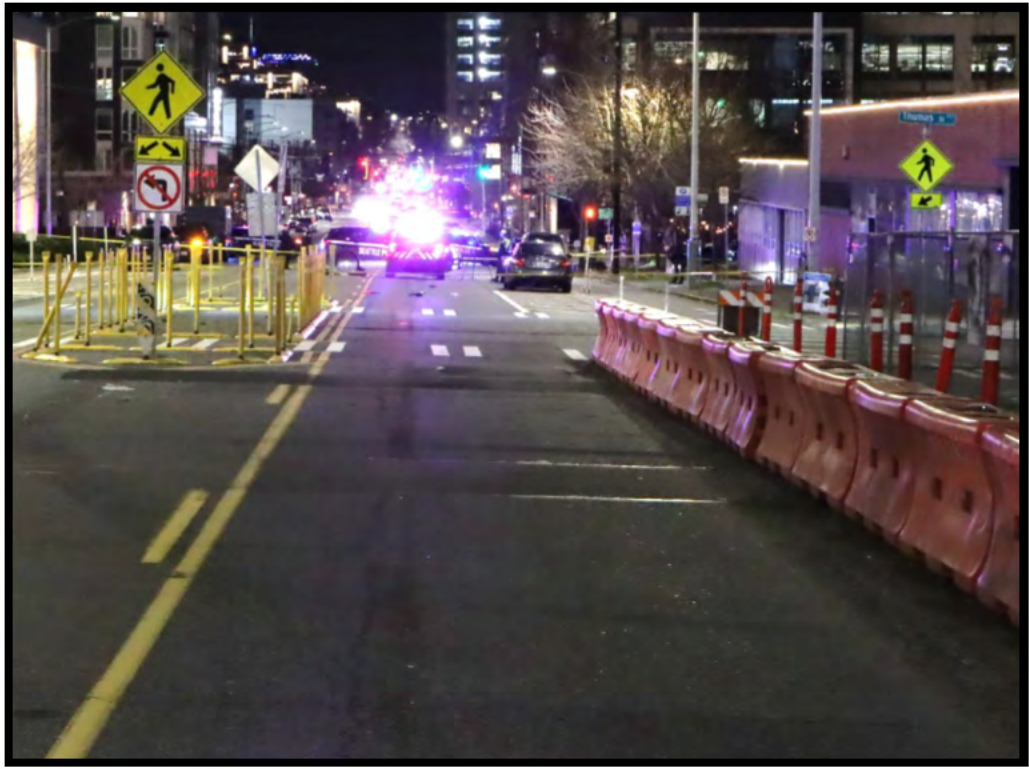
There were yellow plastic pylons attached to c-curbing that were affixed to the roadway. These were placed south of the southern crosswalk with Thomas St and extended northbound past the north crosswalk. The pylons prevented vehicular traffic from crossing Thomas St but allowed pedestrians to cross. There were pedestrian crossing signs placed in the center two-way left turn lane where Thomas St and Dexter Ave N intersected. The roadway surface consisted of asphalt in good repair. Northbound motorists on Dexter Ave N approaching Thomas St experienced an approximate 2-3 percent downhill grade.

On the eastern side of Dexter Ave N north of Thomas St there was a bike lane and a portion of the roadway that contained prohibited street parking. This no parking zone was indicated by diagonal white solid lines painted on the roadway and signs. The west side of Dexter Ave N was configured similarly with a bike lane and a zone of prohibited parking.

**View northbound on Dexter Ave N approaching Thomas St.**

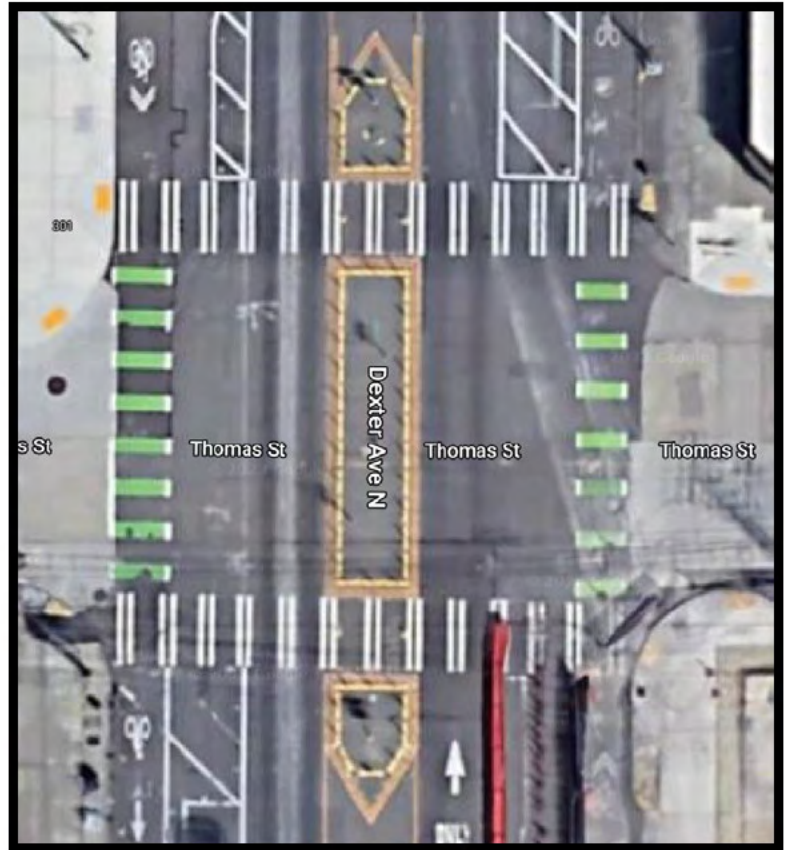
Between Thomas St and John St, Dexter Ave N had construction barricades that created the eastern limit of the northbound lane. There was metal chain link fencing that extended out to the edge of the roadway. The fencing had portions that contained a black partially see-through mesh affixed to the fence. This necessitated the usage of the construction barricades to push the sidewalk into the northbound bike lane. This guarded space was then shared by bicycles and pedestrians. These barricades were approximately 2.5 feet tall and extended along the length of the construction site and up to the southern crosswalk where Thomas St intersected Dexter Ave N. There were no alterations to the northbound lane of travel for vehicles.

**Google Maps overhead view of the intersection. Yellow areas had pylons affixed to roadway.**

There were two marked crosswalks at the intersection of Thomas St. One was on the south side and the other was on the north side of Thomas St. These were identified by solid white lines painted on the roadway in the standard configuration. There were also signs in the middle of the roadway noting the presence of a crosswalk.

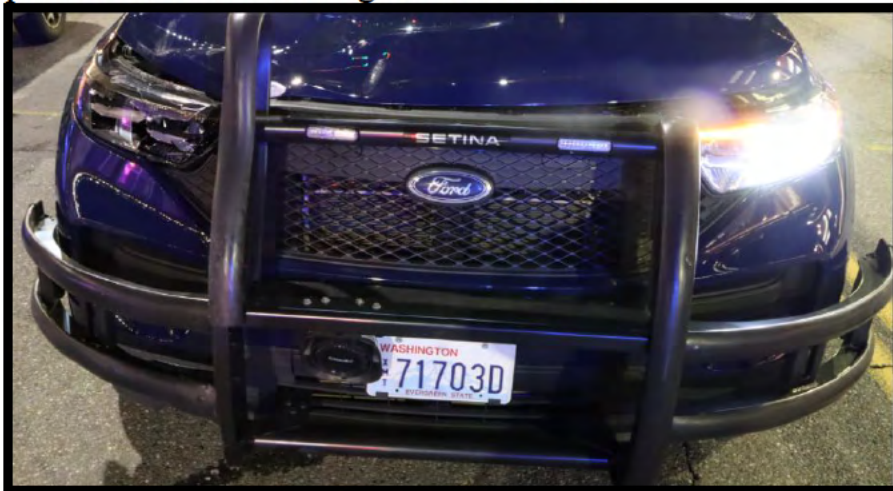
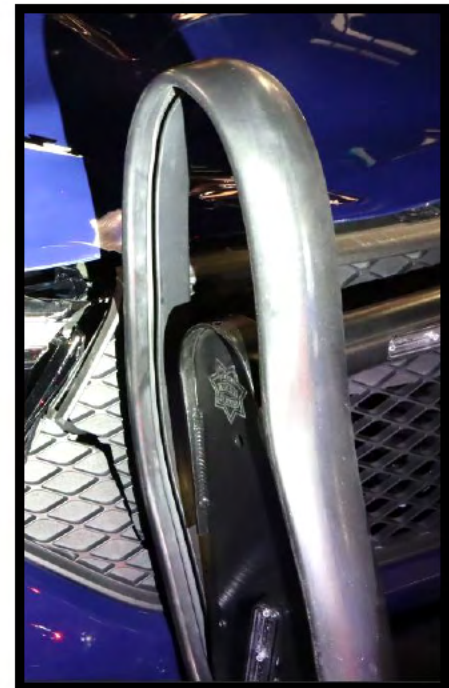
The Ford had damage to the front push bar. The push bar on the vehicle was manufactured by Setina and appeared to be their PB 450L model which consisted of two vertical bars supported by two horizontal center support bars. The push bar was supplemented on the outsides by a Setina P89 fender guard which were two horizontal bars that extended out from the push bar and around to the front wheel opening on both the passenger and driver sides of the vehicle. The push bar and fender guard created the leading edge of the vehicle. The horizontal portions were mounted essentially in-line with the height of the bumper. The two vertical portions of the push bar were mounted inboard of each headlight assembly. The push bar’s vertical portions and portions of the horizontal bars were equipped with rubber protectors.

The rubber protector on the passenger side vertical push bar was pushed upward but was still on the push guard. The bolts in the top bracket for the push bar were damaged and/or missing on the passenger side mount. The bumper cover on the passenger side had damage consistent with the horizontal guard being pushed back and making contact with it.

**Top: Overview of push bar and damage.  
Right: Rubber covering after the collision**

The Ford had damage to the front push bar. The push bar on the vehicle was manufactured by Setina and appeared to be their PB 450L model which consisted of two vertical bars supported by two horizontal center support bars. The push bar was supplemented on the outsides by a Setina P89 fender guard which were two horizontal bars that extended out from the push bar and around to the front wheel opening on both the passenger and driver sides of the vehicle. The push bar and fender guard created the leading edge of the vehicle. The horizontal portions were mounted essentially in-line with the height of the bumper. The two vertical portions of the push bar were mounted inboard of each headlight assembly. The push bar's vertical portions and portions of the horizontal bars were equipped with rubber protectors.

The rubber protector on the passenger side vertical push bar was pushed upward but was still on the push guard. The bolts in the top bracket for the push bar were damaged and/or missing on the passenger side mount. The bumper cover on the passenger side had damage consistent with the horizontal guard being pushed back and making contact with it.

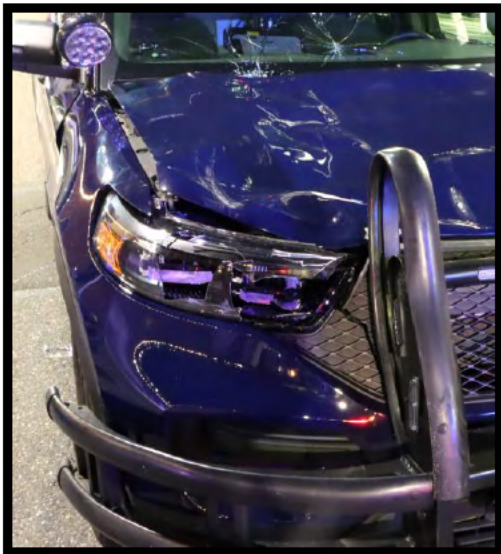
The hood had damage primarily on the passenger side. Damage to the hood consisted of contact and induced damage. The front edge of the hood contained contact damage while the rest appeared to be induced damage. There was distinct gouging on the front hood that appeared to be contact damage. This was later attributed to 1(f), 1(d) left elbow contacting this point. The gouge ran directionally from front to back. There was a feather like material consistent with jacket stuffing that was embedded in the gouge. There was a reddish/pink rubber like material within the gouge that was believed to have been transferred from the outer material of the jacket that 1(f), 1(d) was wearing due to the friction between it and the hood.

**Damage to hood**

The hood had damage primarily on the passenger side. Damage to the hood consisted of contact and induced damage. The front edge of the hood contained contact damage while the rest appeared to be induced damage. There was distinct gouging on the front hood that appeared to be contact damage. This was later attributed to 1(f), 1(d) left elbow contacting this point. The gouge ran directionally from front to back. There was a feather like material consistent with jacket stuffing that was embedded in the gouge. There was a reddish /pink rubber like material within the gouge that was believed to have been transferred from the outer material of the jacket that 1(f), 1(d) was wearing due to the friction between it and the hood.

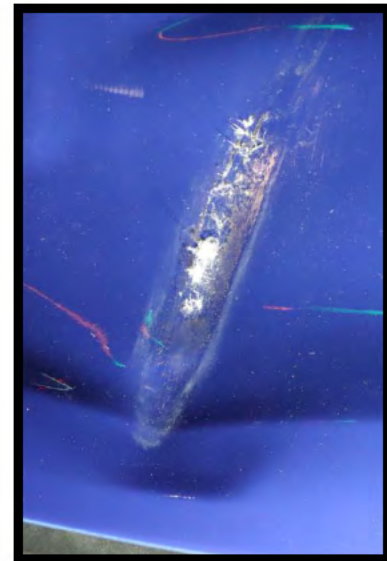
**Marking on hood containing jacket stuffing**

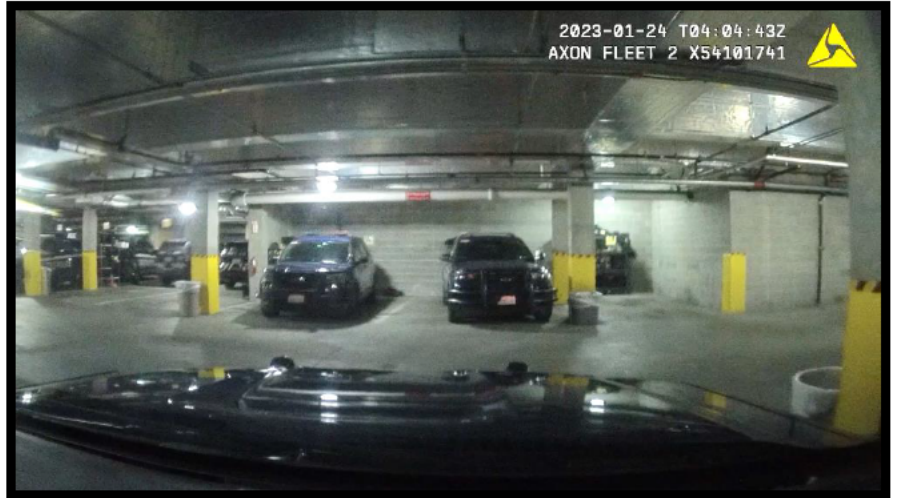
The Ford was equipped with an Axon In-Car Video system. A camera for the system was affixed to the windshield that captured video outward in front of the vehicle. The camera was mounted high up and to the right of center. The Axon recording system had a 1 minute pre-record buffer that would record video but not audio until the recording was activated. However, unlike body worn video (discussed later), speed information is collected and embedded into the

**View from the forward-facing ICV camera.**

video itself. The speed is reported based on GPS data and not from input from the vehicle. This information was not referenced as it appears to have a delay and speed information was available in the BWV. Due to the position where the camera was mounted, the properties of the lens, the angle, and the depth of view the footage was not an accurate representation of what the driver of the vehicle sees. The view of the camera captured the front hood of the vehicle, including the top portions of the push bars. The rest of the frame showed outward in front of the vehicle.

The Ford was equipped with an Axon In-Car Video system. A camera for the system was affixed to the windshield that captured video outward in front of the vehicle. The camera was mounted high up and to the right of center. The Axon recording system had a 1 minute pre-record buffer that would record video but not audio until the recording was activated. However, unlike body worn video (discussed later), speed information is collected and embedded into the video itself. The speed is reported based on GPS data and not from input from the vehicle. This information was not referenced as it appears to have a delay and speed information was available in the BWV. Due to the position where the camera was mounted, the properties of the lens, the angle, and the depth of view the footage was not an accurate representation of what the driver of the vehicle sees. The view of the camera captured the front hood of the vehicle, including the top portions of the push bars. The rest of the frame showed outward in front of the vehicle.

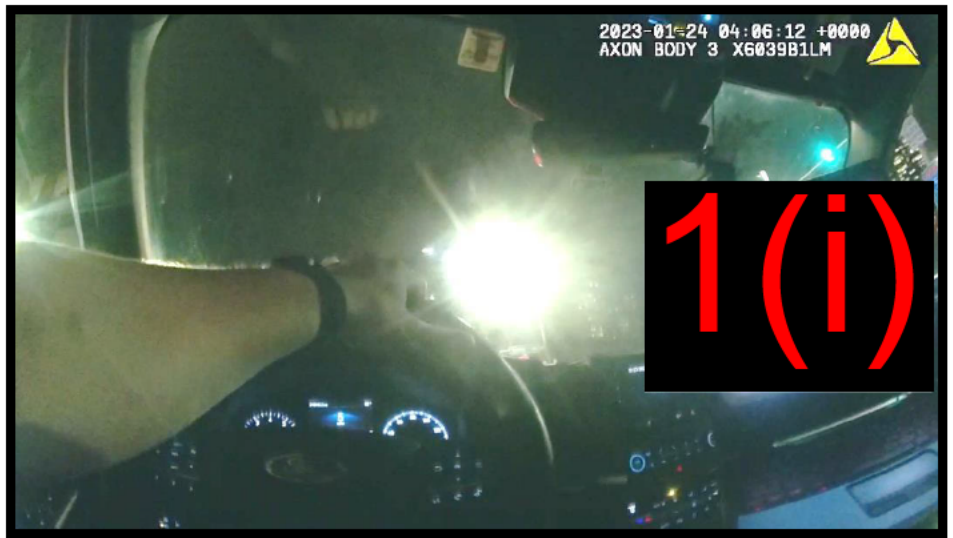
Ofc. DAVE was equipped with an Axon BWV affixed to the outermost layer of his uniform on his chest in a forward-facing position. The Axon recording system had a 1 minute pre-record buffer that would record video but not audio until the recording was activated. It was active and recording during the duration of the initial response to 2023-022228 and the aftermath of this collision.

**View from BWV while seated in the Ford**

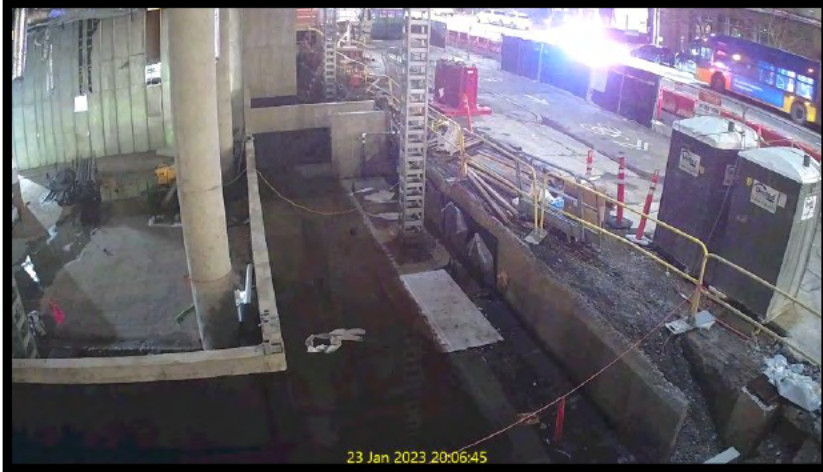
At 20:06:42 (1:29) on the embedded time stamp, the Ford's headlights and emergency lights can be seen on Dexter Ave N headed northbound. At 20:06:46 (1:29) the Ford can be seen exiting the camera's view.

**View from Camera 1. The Ford is seen approaching Thomas St.**

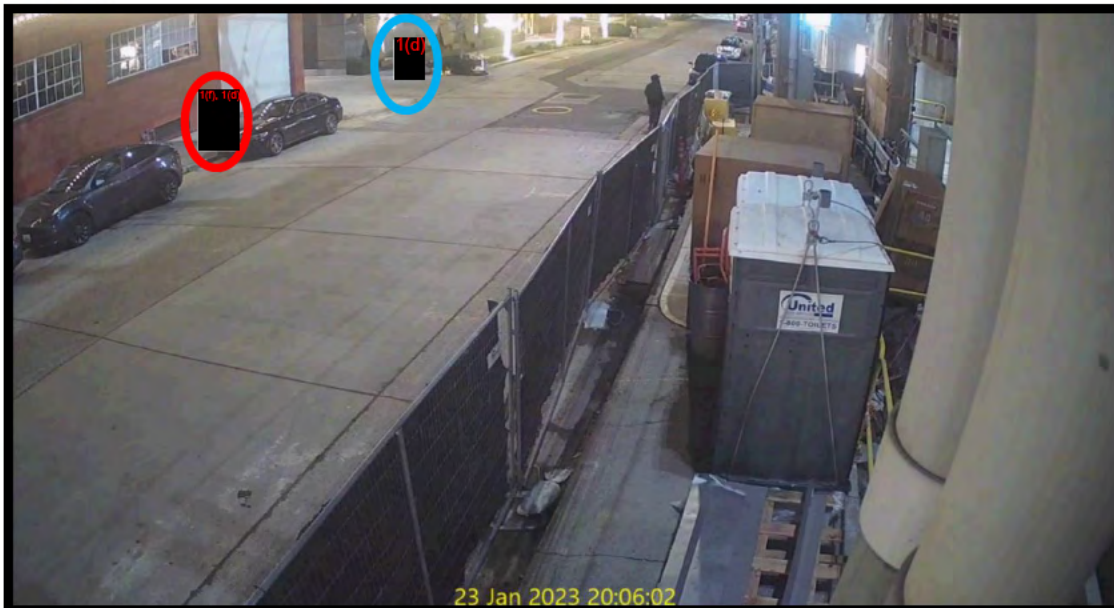
Camera 2: This camera was affixed in an elevated position within the construction site near the southeast corner of Dexter Ave N and Thomas St. It was facing northeast and captured Thomas St east of Dexter Ave N. The video had a duration of 6:28

At 20:05:10 (2:01) on the embedded time stamp, 1(f), 1(d) can be seen crossing Thomas St to the north sidewalk and heading westbound along Thomas St. A person can be seen following and it is presumed to be 1(d) based on her witness statement. At 20:06:07 (2:17) 1(f), 1(d) can be seen exiting the view of the camera. At 20:06:22 (2:21) 1(d) can be seen exiting the view of the camera.

**View from Camera 2. 1(f), 1(d) (circled in red) approaching Dexter Ave N on Thomas St followed by 1(d) (circled in blue).**

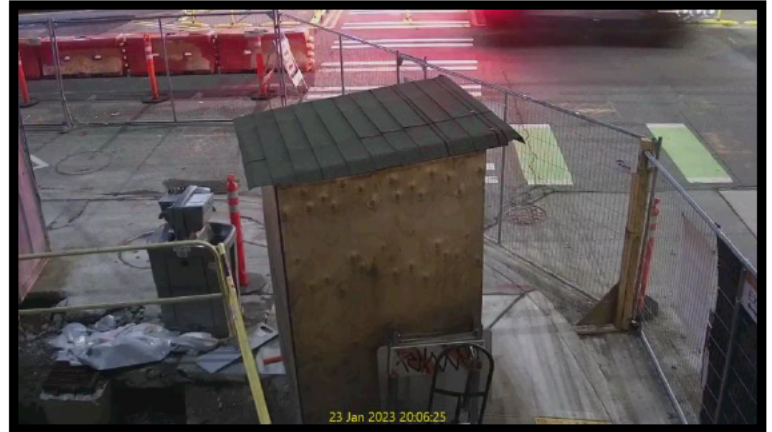
Camera 3: This camera was affixed in an elevated position within the construction site near the southeast corner of Dexter Ave N and Thomas St. It faced west toward Dexter Ave N and captured the south side crosswalk across Dexter Ave N. The top portion of the video captured portions of vehicles northbound on Dexter Ave N. At one point the camera moved and the intersection could be seen but it moved back to its original position and was in this position during the collision. This video had a total duration of 6:48.

**View from Camera 3. Ford passing and brake lights illuminated.**

At 20:06:24 (2:36) red and blue lights could be seen illuminating objects in the camera view. At 20:06:25 (2:36) the Ford can be seen in the intersection and north of the south crosswalk. There was a red illumination that was consistent with the passenger side brake light being illuminated. Moving frame by frame through this time, the Ford only appeared in this position in the video and then was out of the field of view.

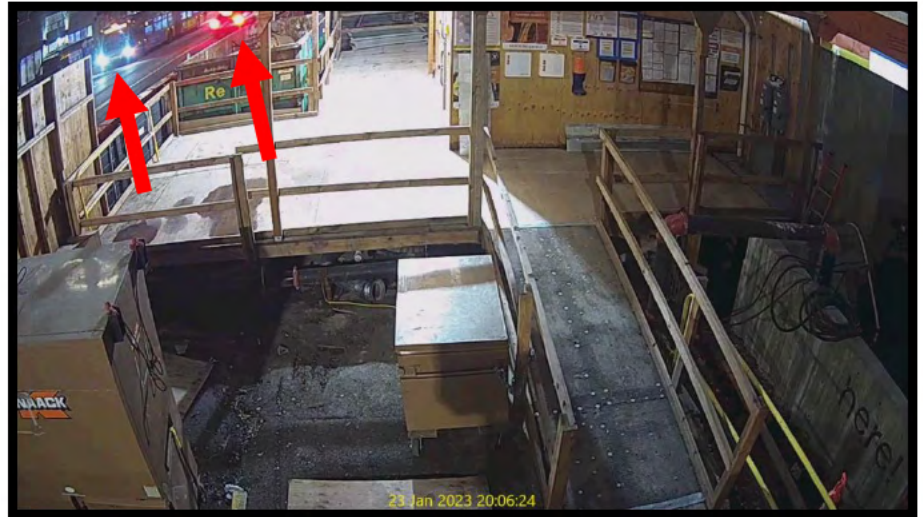
At 20:06:24 (1:25) the Ford can be seen northbound on Dexter Ave N with its overhead lights on. The next position showed the Ford further north along Dexter Ave N with all 3 of its brake lights (left, right and center elevated or third) illuminated. It is difficult to place the vehicle in the roadway in relation to the objects around it, but it appears to be just south of the beginning of the pylons and in-line with the passing KCM bus. At 20:06:25 (1:25) the Ford can no longer be seen but the reflection of the emergency lights can be seen on the side of the bus.

**View from Camera 7. The Ford can be seen with its brake lights illuminated. KCM bus and Ford pointed out with arrows.**

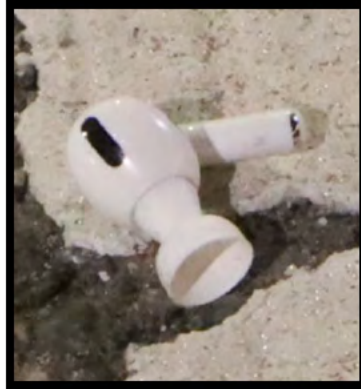
2023-022231-3 Right  
Airpod with rubber tip.

2023-022231-3: This was identified as a right-side Apple Airpod Pro. It had a model number of A2083. It contained the rubber tip on the end. The rubber tip was pulled outward from its original position. This was found approximately 57.5 feet north of the northern edge of the crosswalk. It was approximately 4 feet to the east of the western edge of the east fog line for the northbound lane of travel on Dexter Ave N.

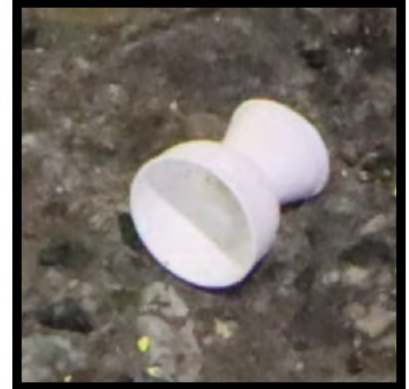
2023-022231-4  
Detachable rubber tip  
for Airpods.

2023-022231-4: This was a detachable rubber tip believed to have been associated with the left-side Apple Airpod Pro. The tip’s end that was inserted in the ear was pulled outward from its original and intended position. This was found approximately 28.3 feet north of the northern edge of the crosswalk. It was approximately 1.5 feet to the east of the western edge of the eastern fog line for the northbound lane of travel on Dexter Ave N.

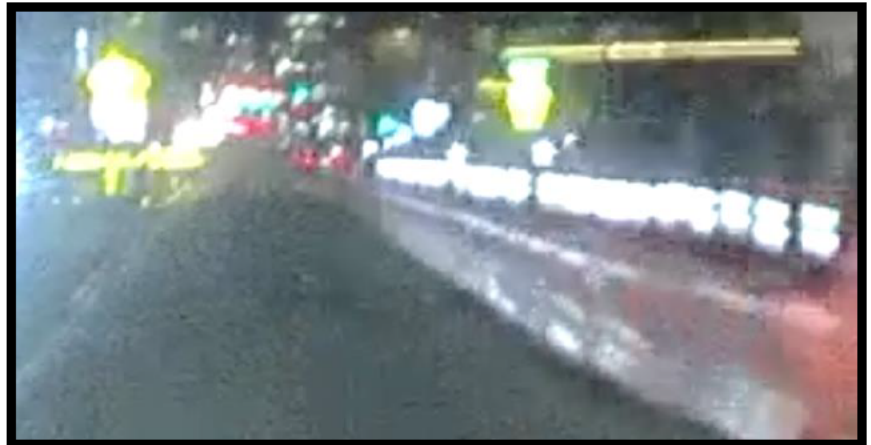
The pylons and signs affixed in the roadway had reflective material that would reflect light back toward approaching vehicles. The vertical pylons were bright yellow. They contained two horizontal yellow stripes of reflective material near the top. There were four signs affixed to the roadway in the south side of the pylon barrier. There was a short sign with yellow and black diagonal stripes. This sign had graffiti on the face of it. The yellow portions of the sign were reflective. 3 signs were affixed to one post behind the short sign. The top of the post had a diamond shaped yellow sign with a black figure in a “walking position” generally indicating a pedestrian crossing. Below that sign was a rectangular yellow sign with black arrows pointed outward from each other and slightly downward indicating the location of the crosswalk. The bottom sign was a square white sign with a red circle and a line through it on top of a 90-degree left arrow indicating “no left turn,” All three of these signs were reflective.

An emergency vehicle with its emergency lights activated approaching this intersection faced a unique scenario. When approaching the intersection, the lights from the emergency equipment would flash off of the signs and the reflective material on the pylons backward toward the driver. This included both the yellow pylons placed in the roadway and the orange pylons placed in the construction zone along the fence line. The reflection of the light made it more difficult to see objects in or beyond the intersection.

**Still shot from ICV of the reflective properties of objects when approaching Thomas St.**

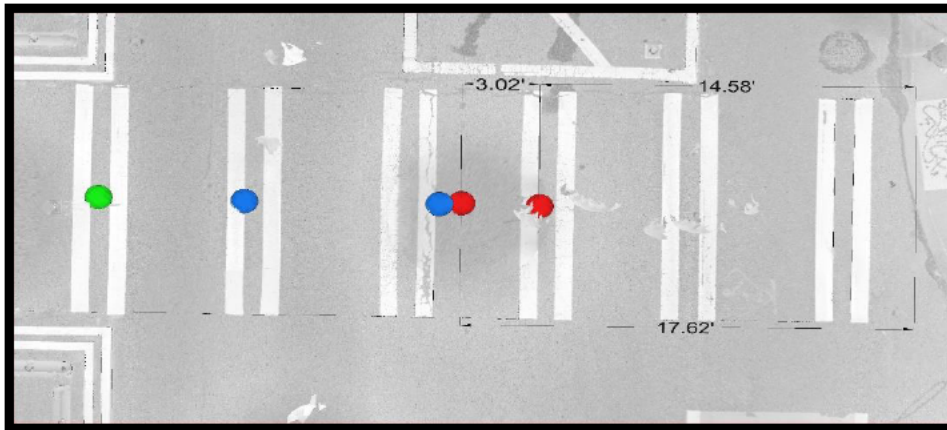
$$d = 17.6 \text{ ft} - 14.6 \text{ ft} \quad d = 3 \text{ ft}$$

$$S = \frac{d}{t} \quad S = \frac{3 \text{ ft}}{.667 \text{ sec.}} \quad S = 6.60 \text{ FPS or } 4.5 \text{ MPH}$$

**3D scan showing walking (red circle) distances.**

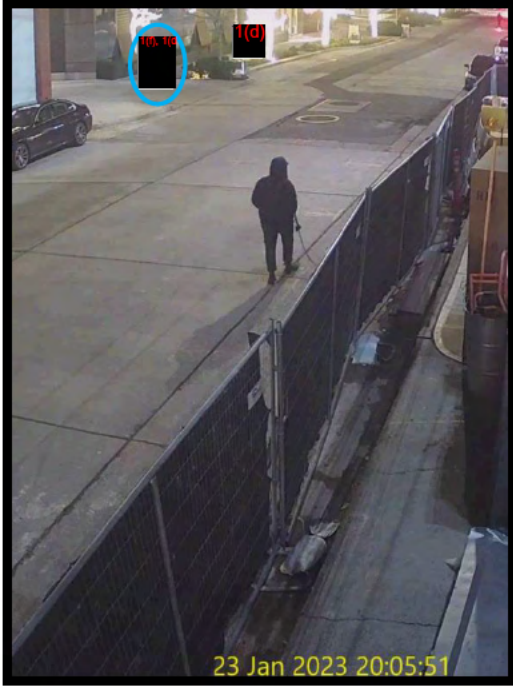
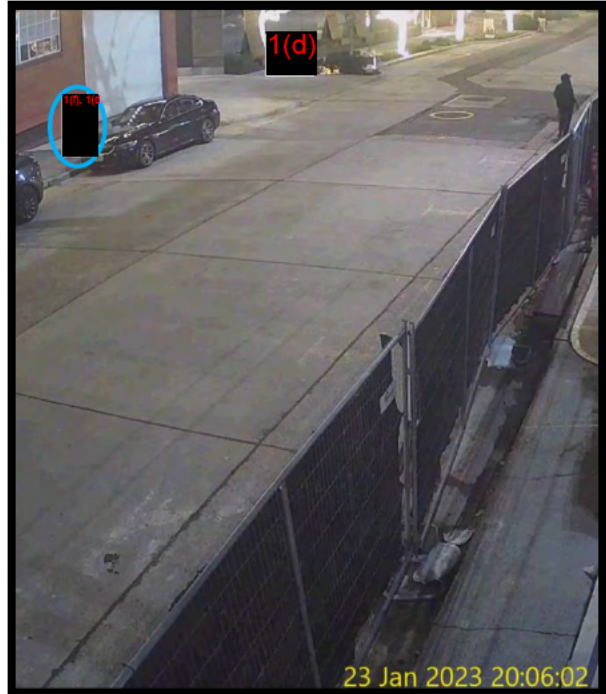
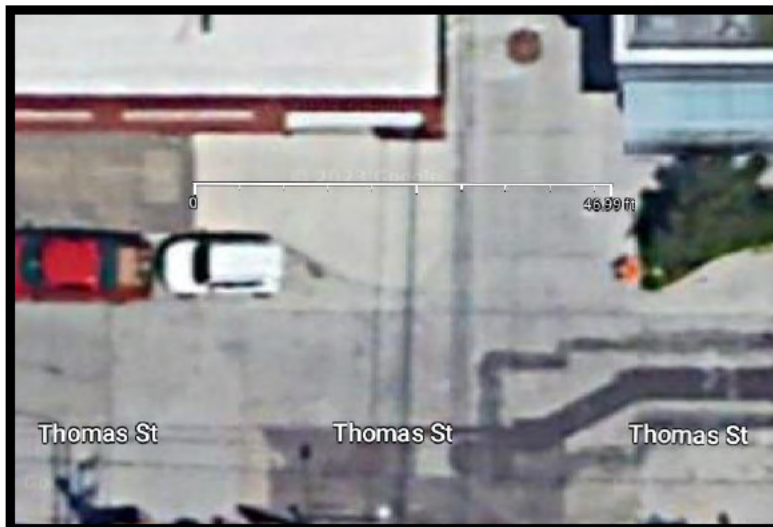
Camera 2 from the construction site that captured **1(f), 1(d)** approaching Dexter Ave N from the east was used to also find a walking pace. Fixed points were found on the video and the embedded time stamp<sup>5</sup> was used to measure the time it took **1(f), 1(d)** to travel that distance. The first fixed point was where **1(f), 1(d)** had entered into the alley. The affixed time stamp for this was 20:05:51. The second point was where **1(f), 1(d)** was passing a point on the sidewalk that was a different color than the rest of the sidewalk. The embedded time stamp for this was 20:06:02. The distance between these two points were measured using Google Maps and was approximately 47 feet. It took **1(f), 1(d)** approximately 11 seconds to travel the 47 feet which gave an average walking pace of 4.3 FPS.

Upper Left: Starting point for 1(f), 1(d) walking pace.  
Upper Right: Ending Point for 1(f), 1(d) walking pace.  
Below: Google Maps measurement of the distance.

Camera 2 from the construction site that captured 1(f), 1(d) approaching Dexter Ave N from the east was used to also find a walking pace. Fixed points were found on the video and the embedded time stamp[5] was used to measure the time it took 1(f), 1(d) to travel that distance. The first fixed point was where 1(f), 1(d) had entered into the alley. The affixed time stamp for this was 20:05:51. The second point was where 1(f), 1(d) was passing a point on the sidewalk that was a different color than the rest of the sidewalk. The embedded time stamp for this was 20:06:02. The distance between these two points were measured using Google Maps and was approximately 47 feet. It took 1(f), 1(d) approximately 11 seconds to travel the 47 feet which gave an average walking pace of 4.3 FPS.

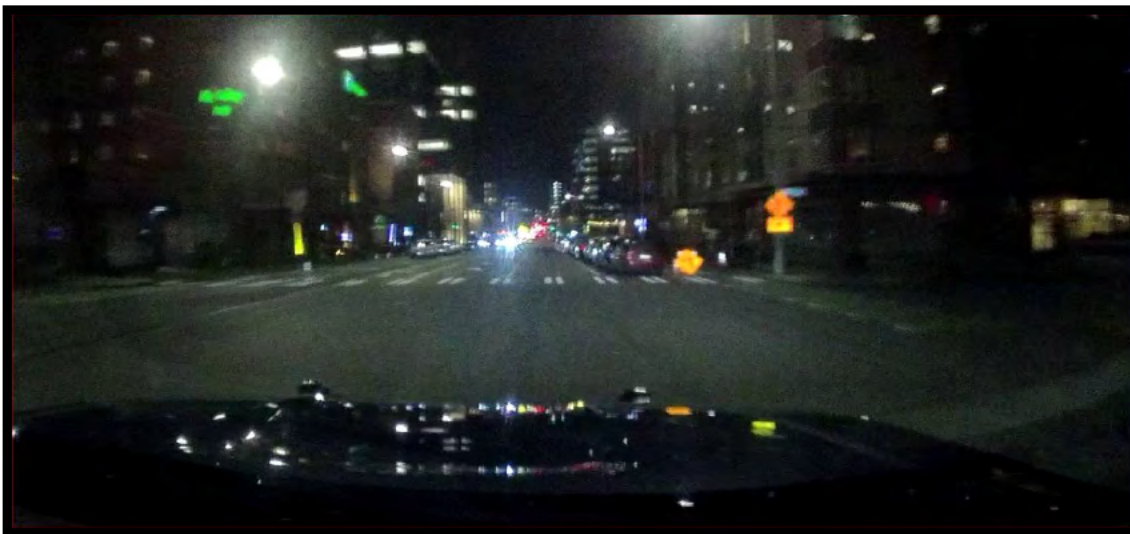
$$t = \frac{d}{S} \quad t = \frac{17.6 \text{ ft}}{4.30 \text{ FPS}} \quad t = 4.09 \text{ seconds}$$

The Ford's ICV was then moved back approximately 4.09 seconds from this point and to measure how far to the south of the northern crosswalk it was when 1(f), 1(d) was estimated to have entered the roadway. The Ford was just entering the intersection of John St approximately 475 feet to the south of the northern crosswalk at Dexter Ave N and Thomas St.

Ford's approximate position when 1(f), 1(d) began entering the crosswalk using a 4.3 FPS

It is likely that 1(f), 1(d) pace would not have changed much between her approach to the intersection and when she was crossing Dexter Ave N. The 4.3 FPS pace was used to determine where the Ford approximately was on Dexter Ave N when 1(f), 1(d) entered the crosswalk. The point where 1(f), 1(d) (17.6 feet from the east sidewalk) transitioned to a run was used as she could more accurately be placed in the roadway. A measurement of time was found to see how long it took her to reach this position from the east sidewalk.

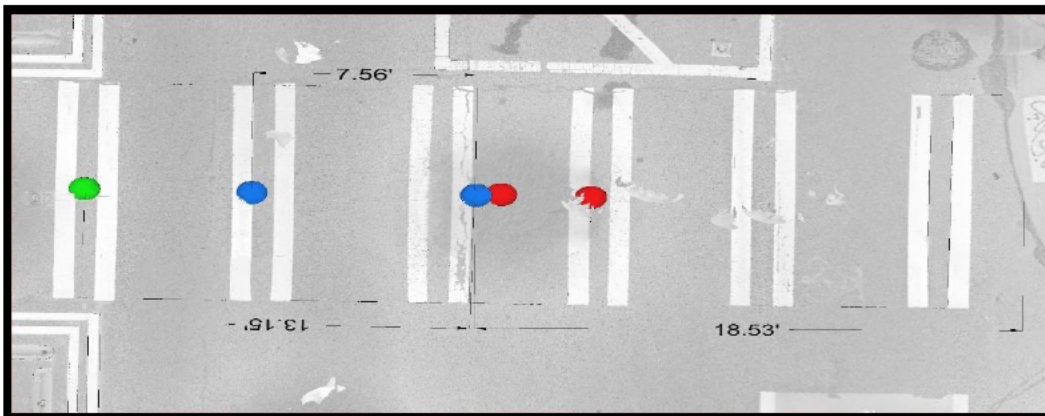
At the point where 1(f), 1(d) was observed beginning to run, she was 13.2 feet to the east of the shared center left turn lane and just east of the northbound lane of travel. To reach this point of relative safety, it would have taken her 1.56 seconds at the measured average running pace.

$$t = \frac{d}{S} \quad t = \frac{13.2 \text{ ft}}{8.44 \text{ FPS}} \quad t = 1.56 \text{ seconds}$$

3D scan showing running (blue circles) distances. Walking represented by red circles. Green is the area where 1(f), 1(d) is clear of the northbound lane.

At the point where 1(f), 1(d) was observed beginning to run, she was 13.2 feet to the east of the shared center left turn lane and just east of the northbound lane of travel. To reach this point of relative safety, it would have taken her 1.56 seconds at the measured average running pace.

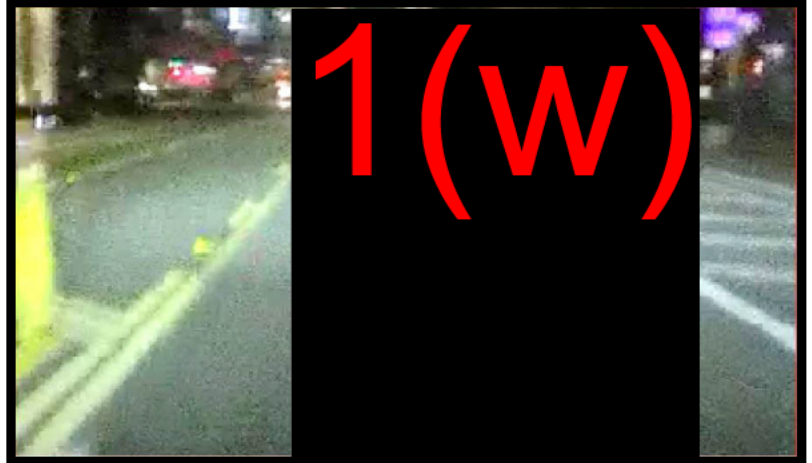
1(f), 1(d) was in the process of crossing Dexter Ave N at Thomas St within the northern crosswalk. Based on the witness account and the ICV, 1(f), 1(d) entered the intersection and was walking as she crossed. 1(f), 1(d) was approximately 18.7 feet into the crosswalk. At this position, 1(f), 1(d) was still to the east of the lane of northbound vehicular travel for Dexter Ave N. Though she was in the roadway, and moving east to west, this position would have allowed vehicles to pass her without striking her. At this point 1(f), 1(d) began to transition to a run to continue her movement westbound. 1(f), 1(d) ran approximately 8.3 feet further westbound into the crosswalk. This placed her nearly in the center of the northbound lane of Dexter Ave N and in the path of the Ford.

ICV still showing the clothing worn by

1(f), 1(d)
